Lessons Learned for Puerto Rico's Transportation Infrastructure after Hurricane María

BY BENJAMÍN COLUCCI RÍOS, PH.D., P.E., ALBERTO M. FIGUEROA MEDINA, PH.D., P.E., AND ALEXANDER MOLANO SANTIAGO, BSCE

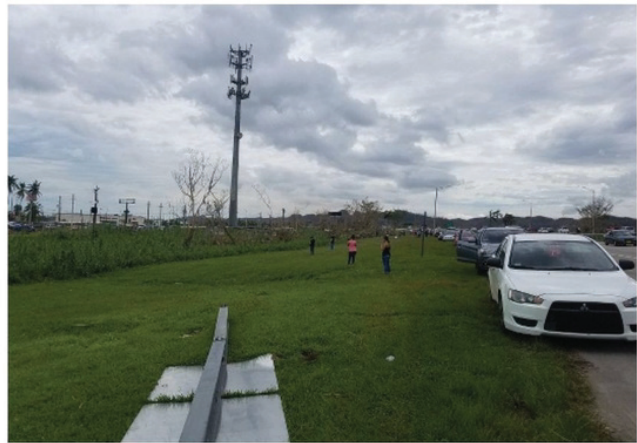
Figure 3. Citizens searching for mobile phone signal on freeway PR-22 in Toa Baja.

Another effect on the highway system was the presence of citizens roaming the roads searching for mobile (cellular) signal due to the collapse of communication antennas. As telephone and cellular services were slowly restored, many citizens set out to look for places with cellular signal reception along the roads, stopping at the roadside (even in expressways and highways) where they could reach the service (Figure 3). In such situations, the presence of shoulders provided some degree of separation between the citizens and the adjacent vehicular traffic.

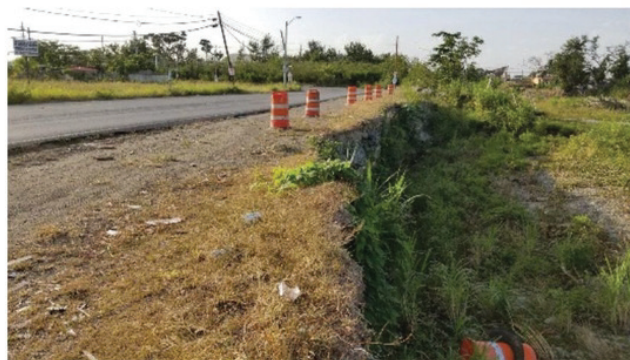
Figure 4. PR-511 Real Anon roadside damage.

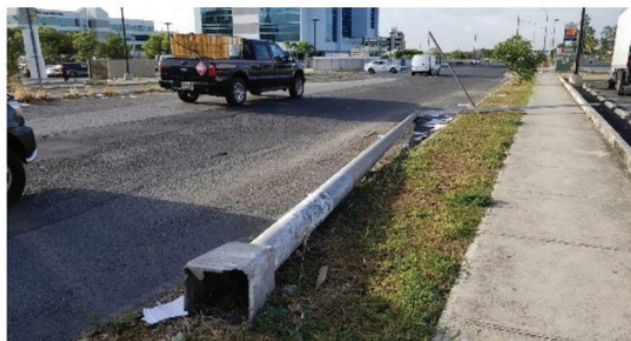
Figure 5. PR-506 downed pole near hospital in Coto Laurel.

The designs of utility poles and luminaires (steel, concrete and wood) that failed at the base and at their upper third portion must be evaluated for their resistance to wind load. This review should consider the properties of the materials, the cross section and the aerodynamic response to gusts. The design of lateral signs and directional signs of overhead signs, in particular those with an impact-yielding base design, must be revisited. A design option whose performance was favorable to Hurricane María was the overhead gantry configuration. The horizontal arm, being fixed at both ends, is not subject to rotation or eccentricity of wind loads and therefore is more stable.
